Manhole Inspection Summary

Manhole # S07II2007MH

Location Address: **6333 WILLOW GLEN DR** Cross Street: **OLD PIMILIOC RD**

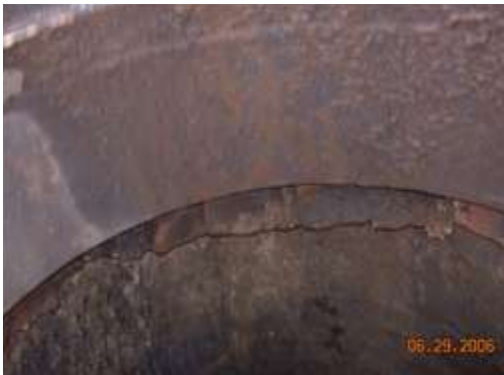
Defect

Chimney / Frame Adjustment ☒ Exists Material: **Brick** ☐ Parged Height: **1** (in.)
Condition: ☐ Sound ☐ Cracked ☐ Root Intrusion ☒ **Loose Brick** ☒ **Deteriorated**
Infiltration: ☐ None ☒ **Joint** ☐ Cracks ☐ Mortar ☐ Roots ☐ Wall

Frame leak, adjustment infiltration and deterioration

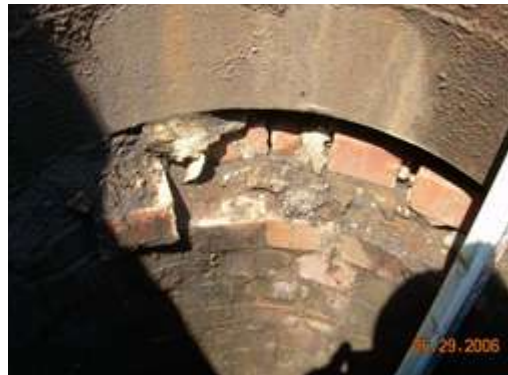
Defect

Frame leak, adjustment deterioration and loose bricks

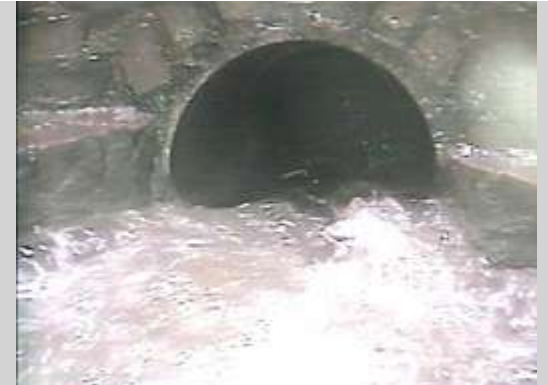
15 in. Circular Gravity Sewer Pipe Out @ 12 O'Clock

Infiltration: **Evidence** Pipe Seal Cond: **Sound**

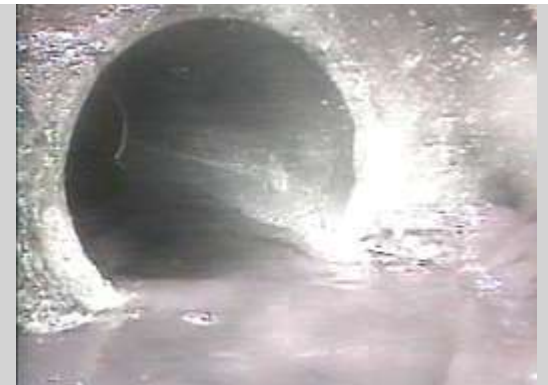
8 in. Circular Gravity Sewer Pipe In @ 3 O'Clock

Infiltration: **Evidence** Pipe Seal Cond: **Unknown**

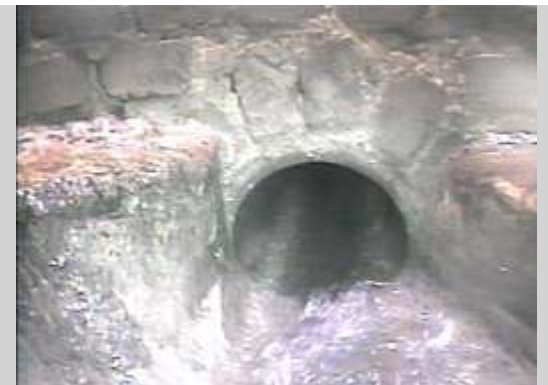
Pipe In @ 7 O'Clock

Comments **Heavy flow from county not shown on GIS from I7 direction.**

Connects To: **County (No manhole in GIS)**
